Site 54 Red Gate Marsh

Great Marsh Coastal Wetlands Restoration Plan
Rapid Technical Assessment Site 54

Site # 54
Red Gate Marsh

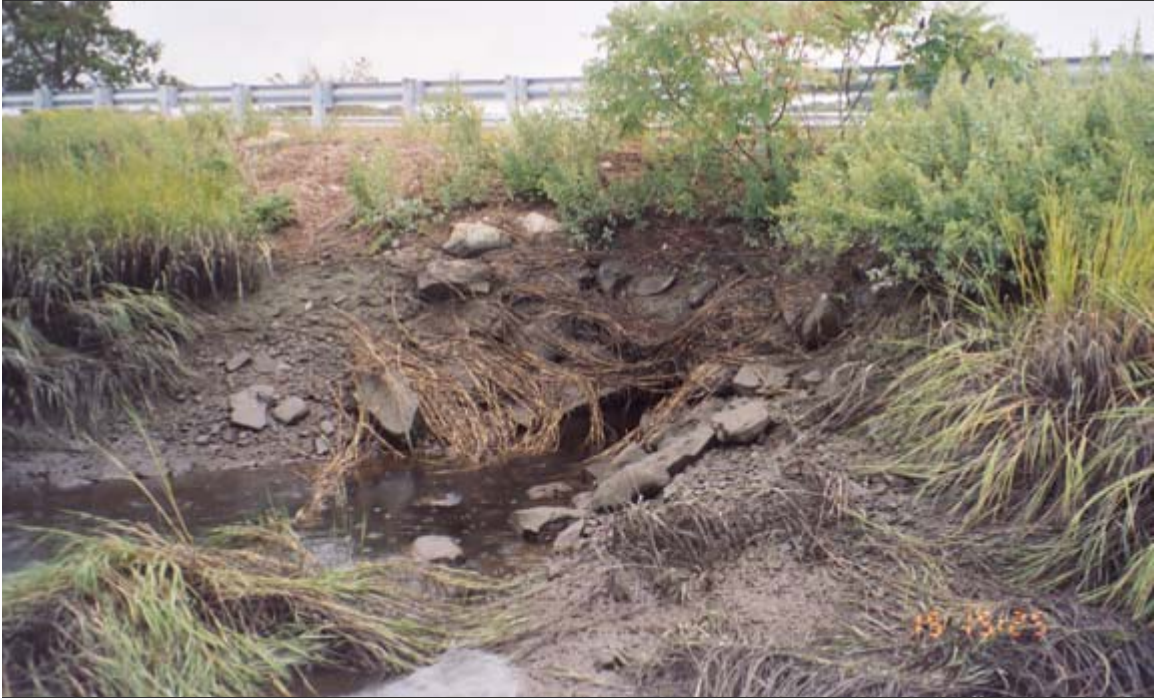
Photo 1 - View of Downstream End of Northern Culvert Crossing

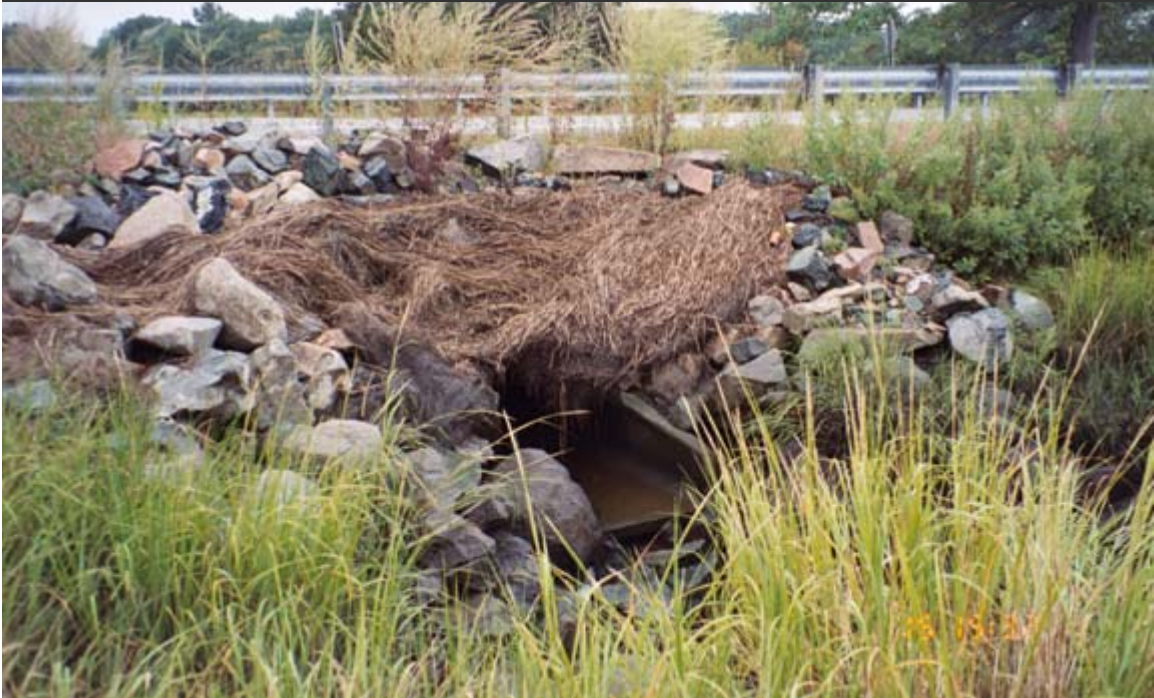
Photo 2 - View of Downstream End of Southern Culvert

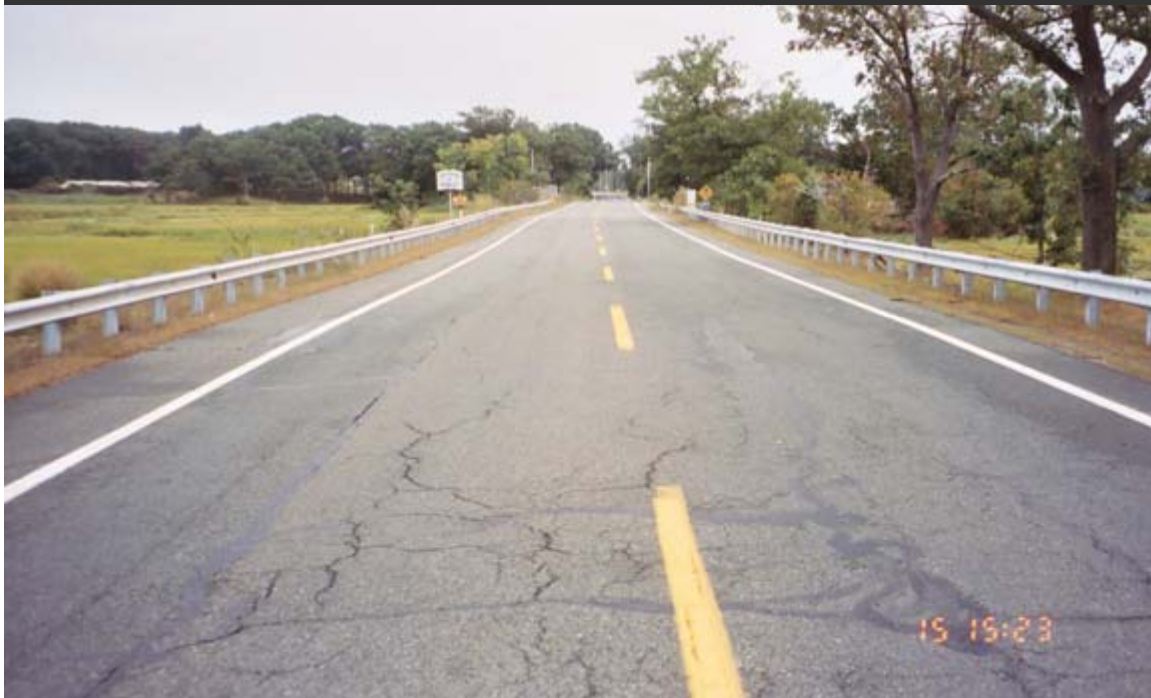
Photo 3 - Route 1A at Crossing Viewing South

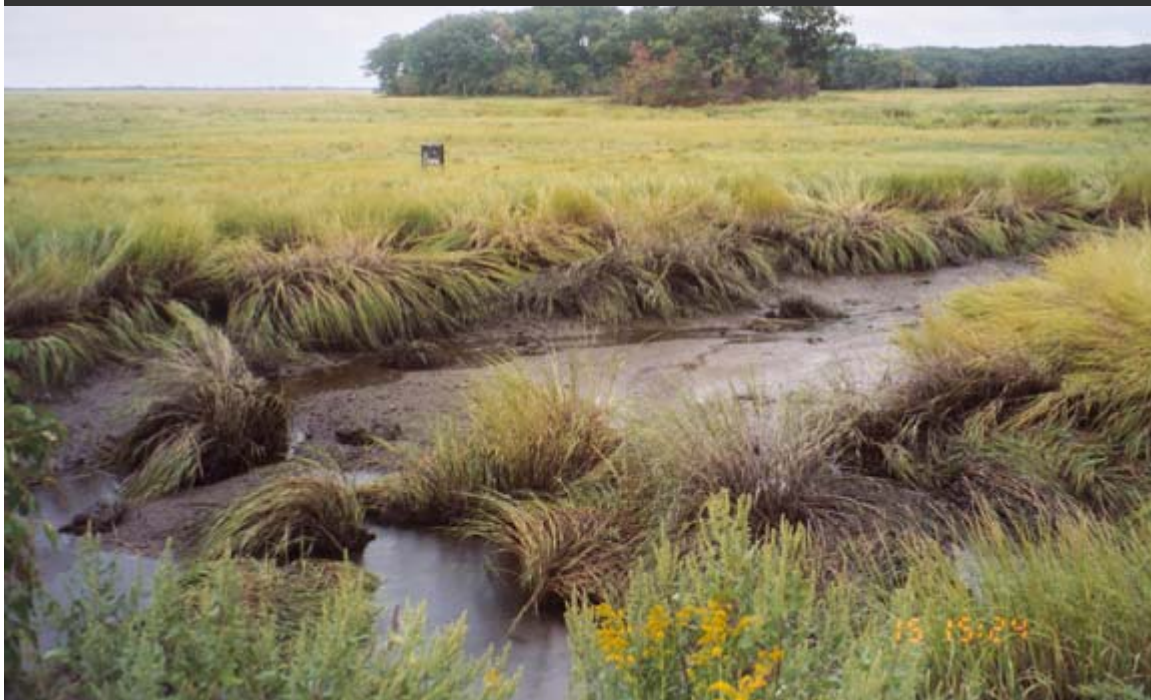
Photo 4 - View of Downstream Marsh at Northern Crossing

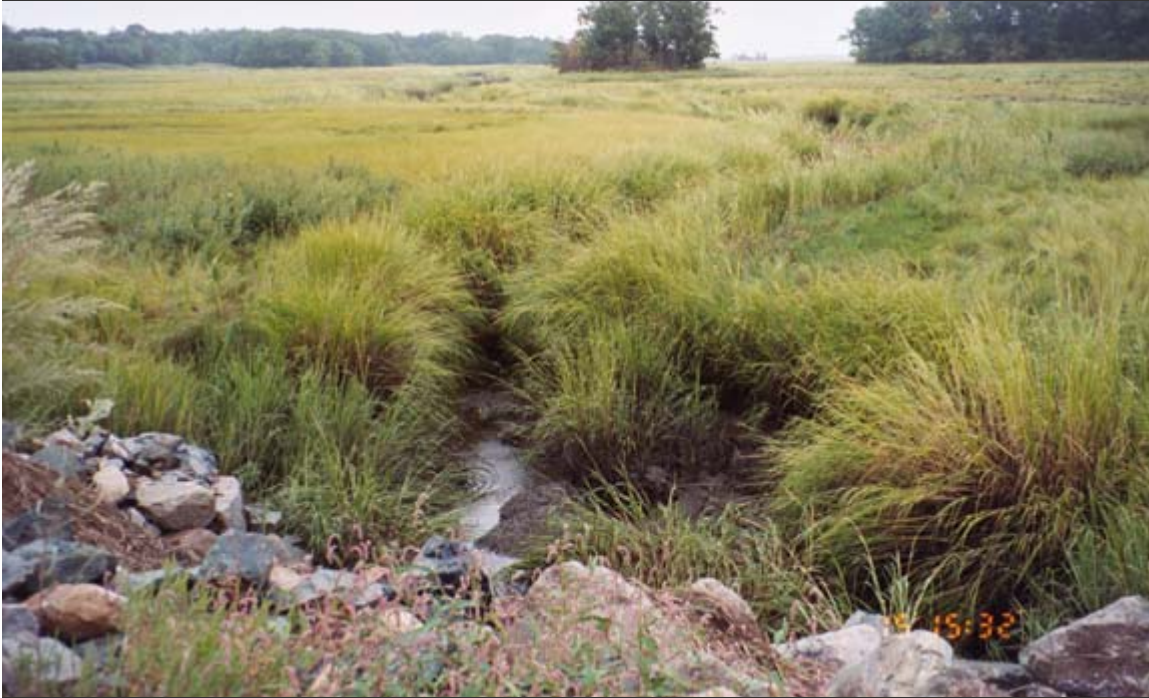
Photo 5 - View of Marsh Downstream of Southern Culvert Viewing Northeast

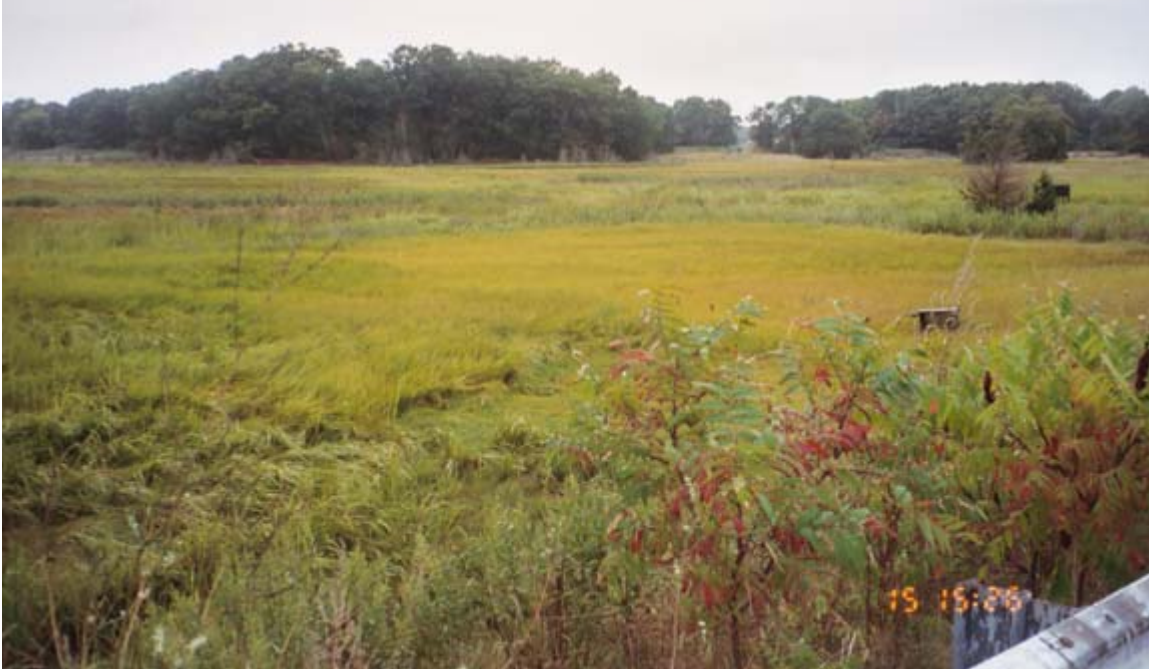
Photo 6 - View of Marsh Upstream of Northern Culvert Crossing Viewing Northwest

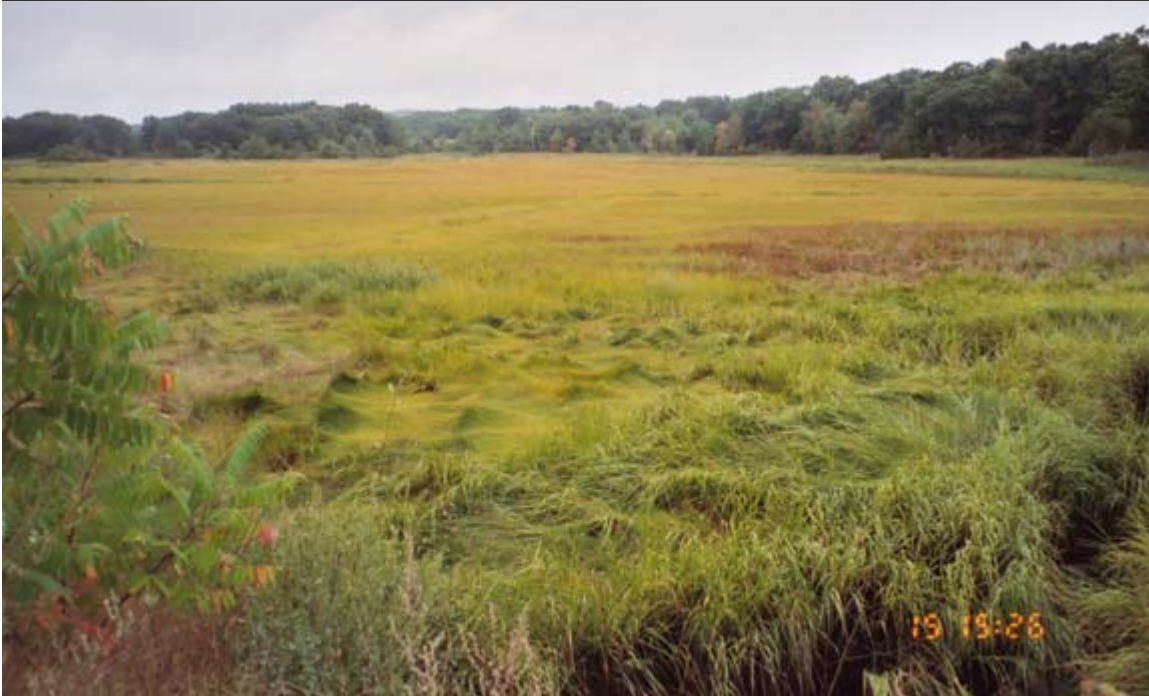
Photo 7 - View of Marsh Upstream of Northern Culvert Crossing Viewing Southwest

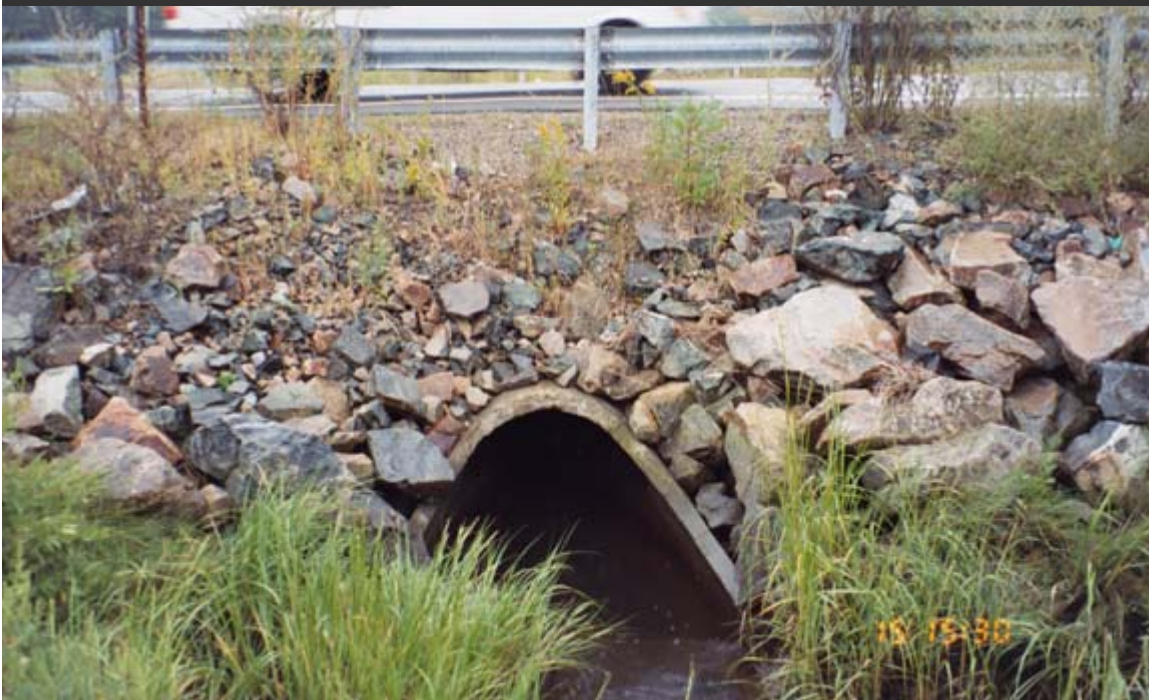
Photo 8 - View of Upstream End of the Northern Culvert
